Project number: 101111888
Project acronym: SHIMMER
Project duration: 09/2023 – 08/2026
Project Coordinator:
Diana González, SINTEF AS – Institute
SINTEF Industry

Safe Hydrogen Injection Modelling and Management for European gas network Resilience

D3.3 Report on recommendation and guidelines for inspection of pipelines for H-NG blends

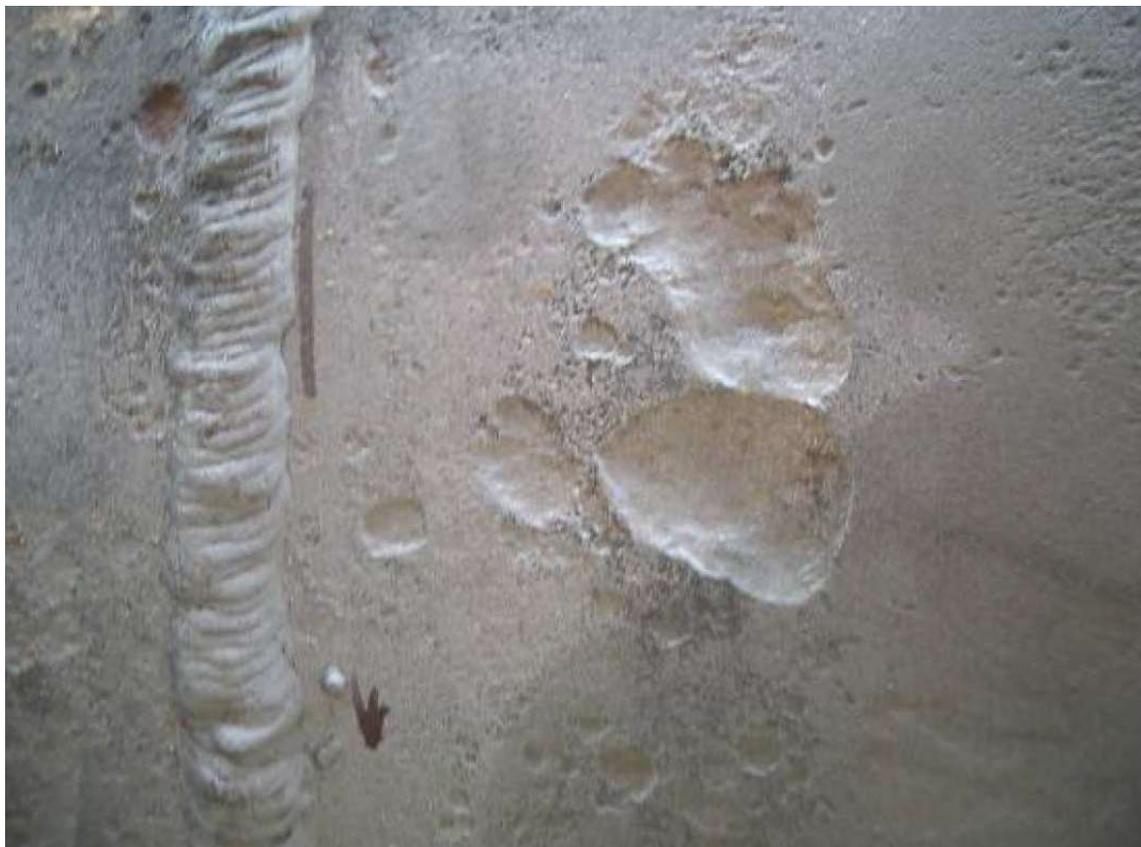
Figure 4-3: Example of external corrosion defects detected via MFL [2]

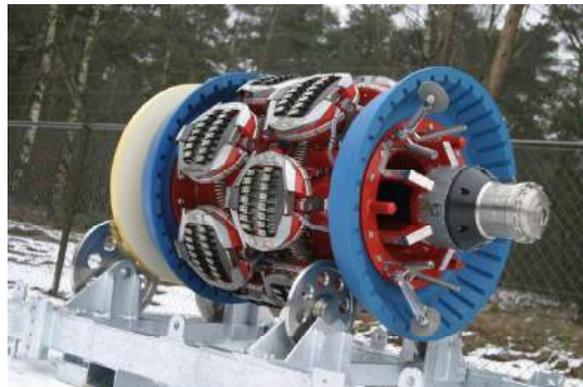
Figure 4-5: Circumferential MFL (MFL-C) from ROSEN [4]

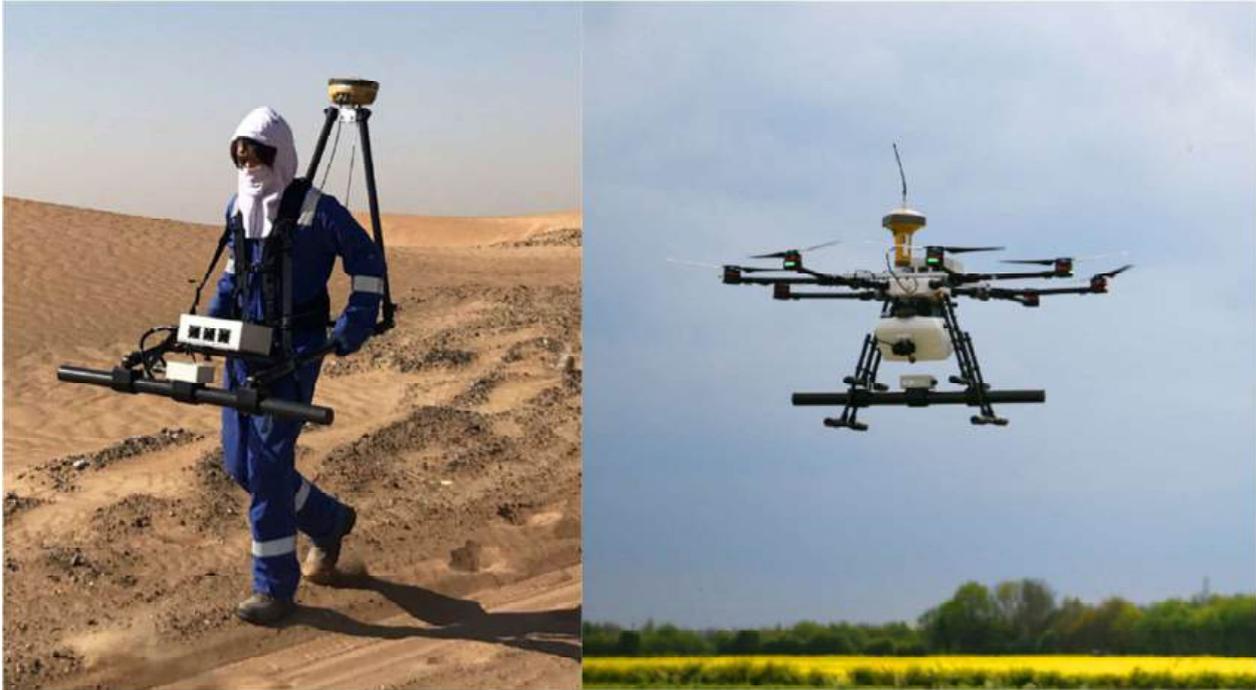
Figure 4-35: SCT test [24]

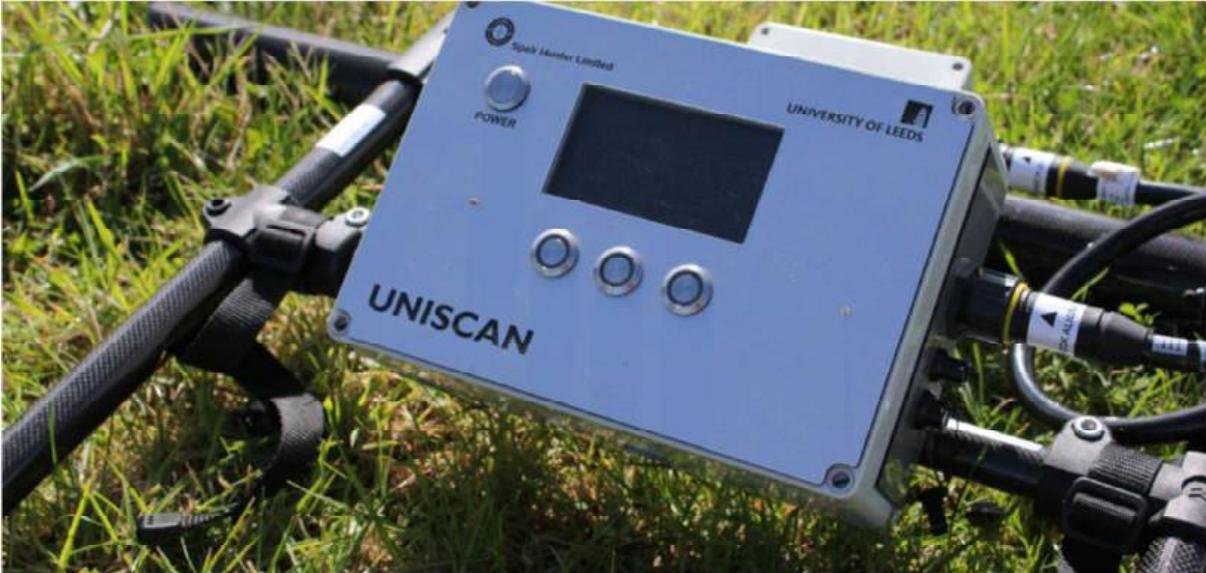
Figure 4-36: UNISCAN- SCT device [24]

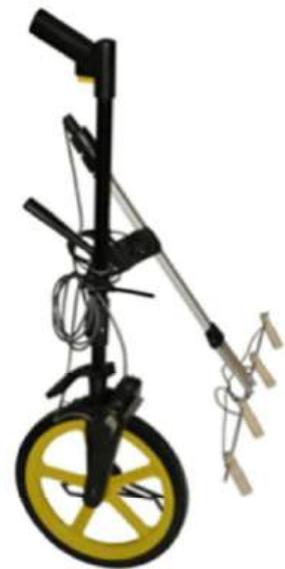
Figure 4-38: Scanning device [29]

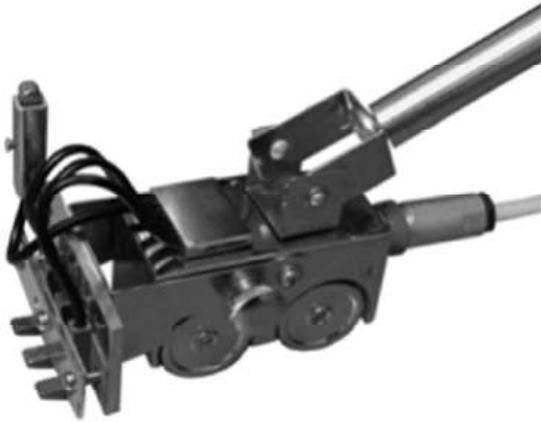
Figure 4-39: Scanning device Type 1-8M [28]

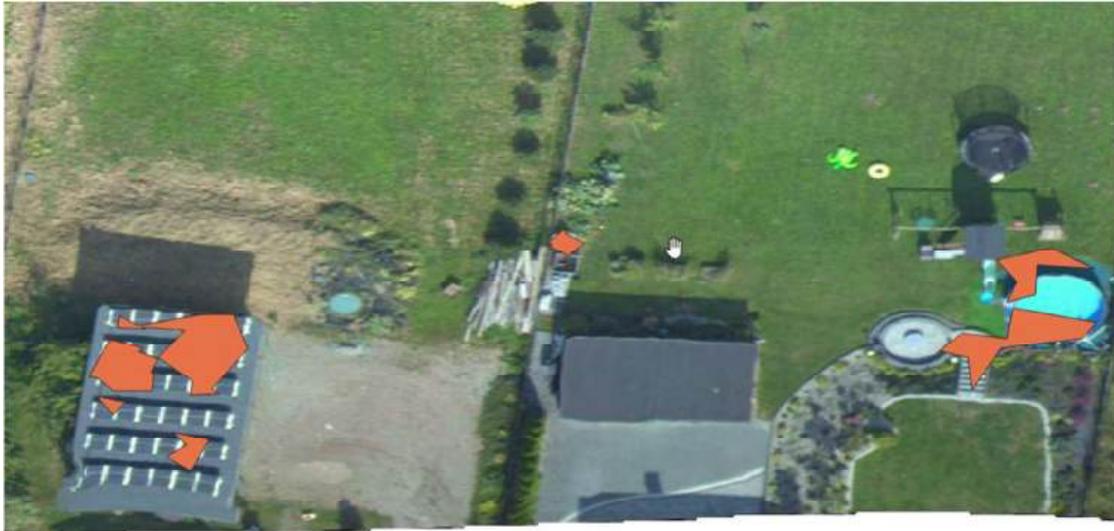
Figure 4-52: Example of incorrect identification of a storage area [38]

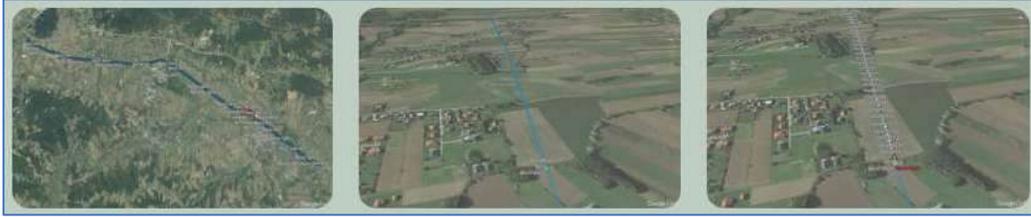
Figure 5-1: Selection of a representative section of the gas pipeline for field surveys using non-destructive (NDT) inspection methods [source GAZ-SYSTEM]

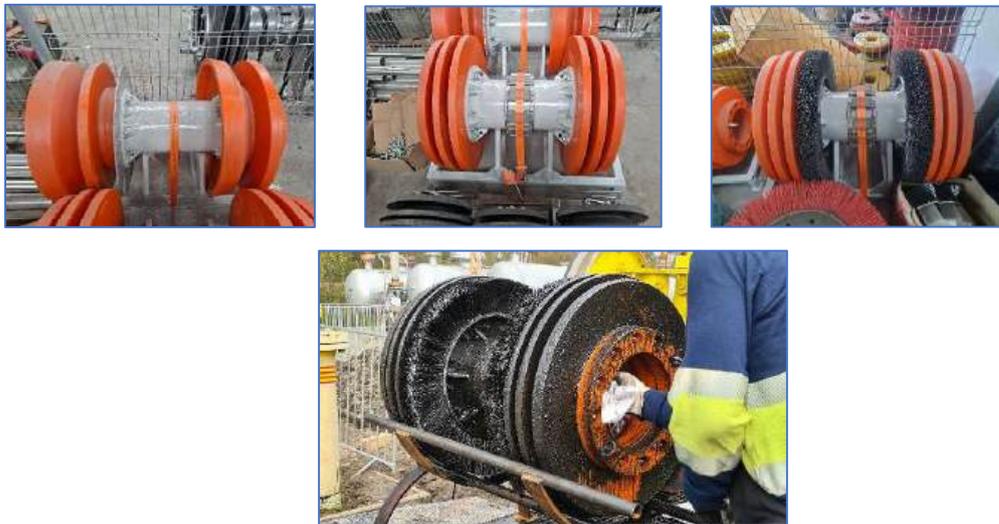
Figure 5-3: Photographies of cleaning pigs used [source GAZ-SYSTEM]

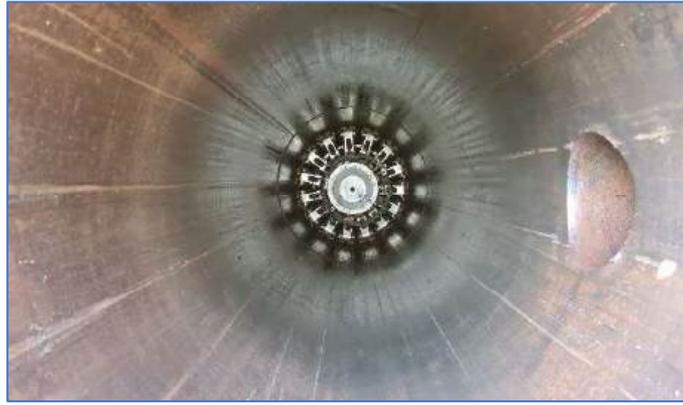
Figure 5-4: Photography of the MFL inspection tool installed inside the pig launcher
[source GAZ-SYSTEM]

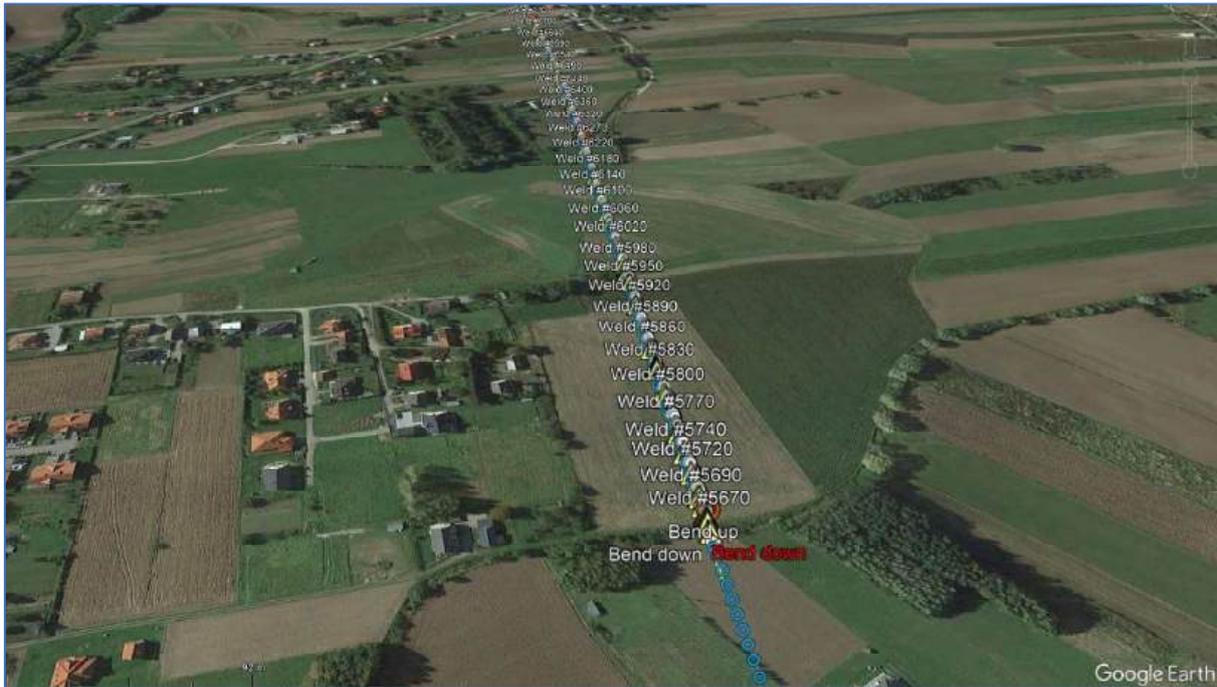
Figure 5-8: Appearance of feature points obtained from the reference survey in the Google Earth application [source GAZ-SYSTEM]

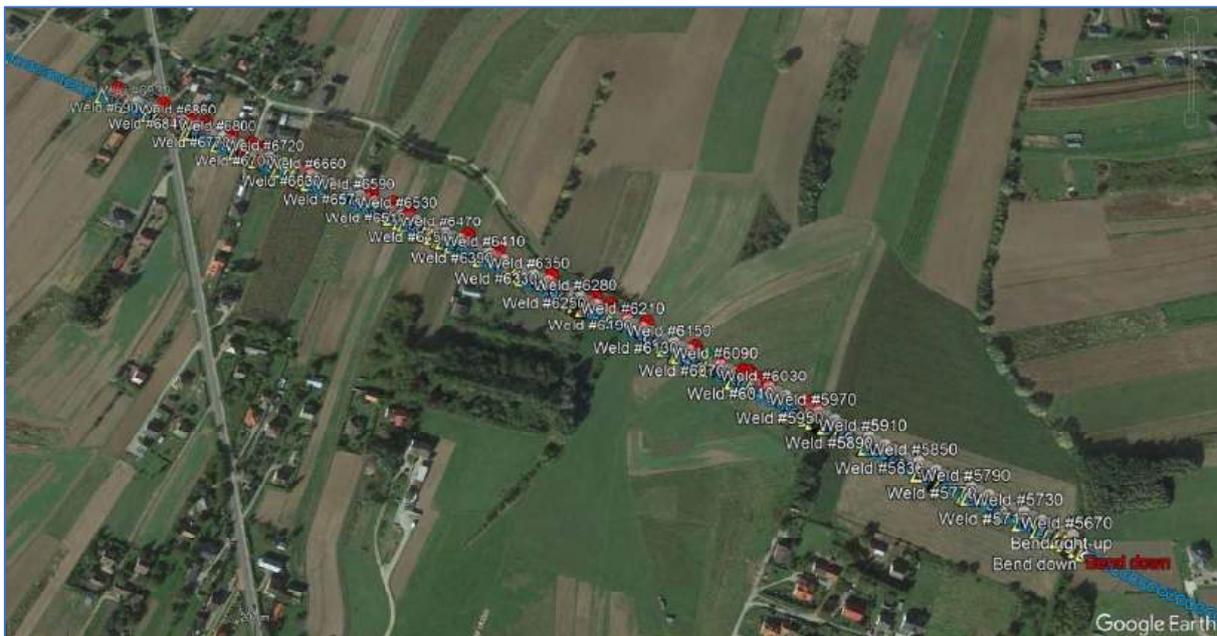
Figure 5-9: Overlay of all methods on the examined section of the gas pipeline. Data presented in Google Earth [source GAZ-SYSTEM]

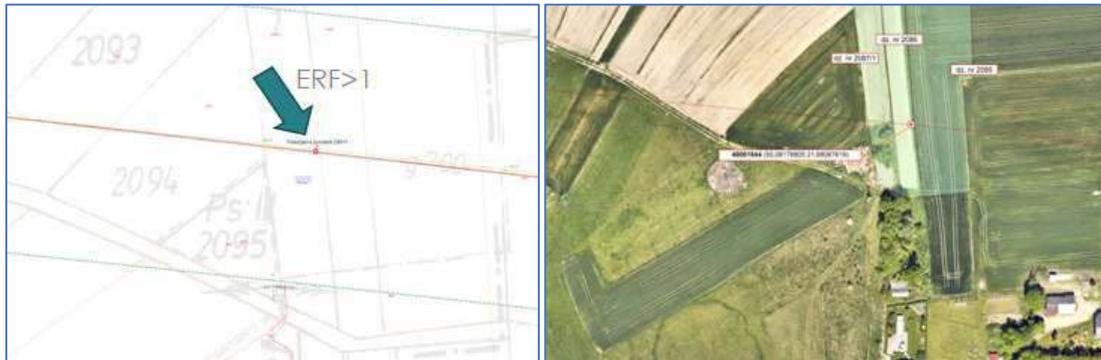
Figure 5-10: Localization of the ERF ≥ 1 defect in the field [source GAZ-SYSTEM]

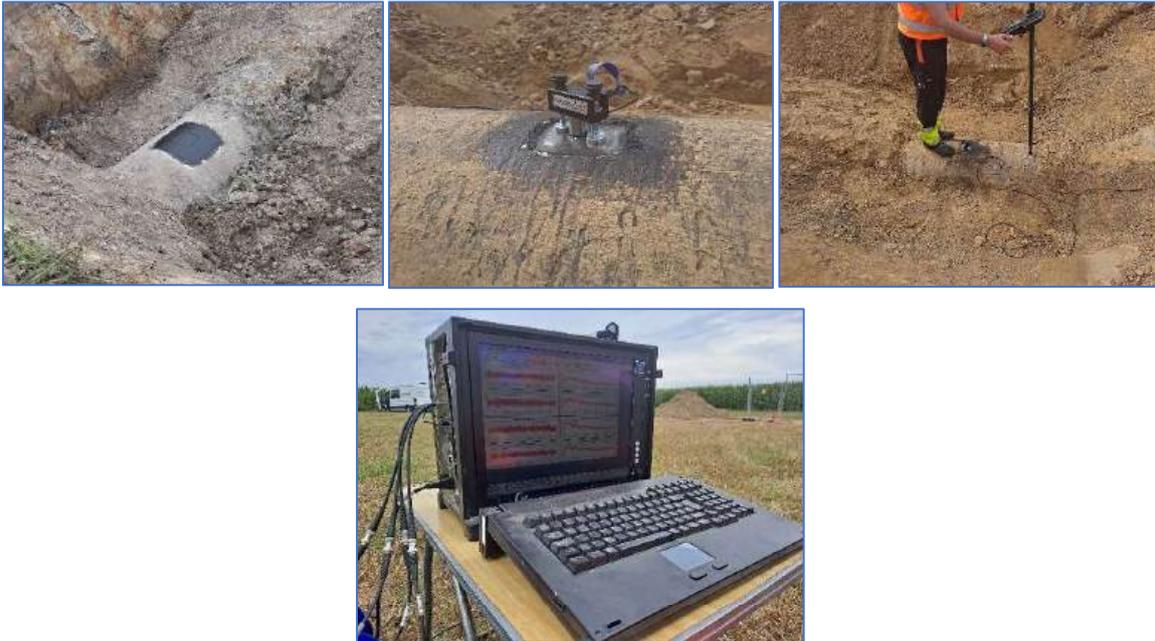
Figure 5-11: Installation and geodetic coordinates measurements of the location of AE sensors on the pipeline wall, connection of sensors to the signal recording computer [source GAZ-SYSTEM]

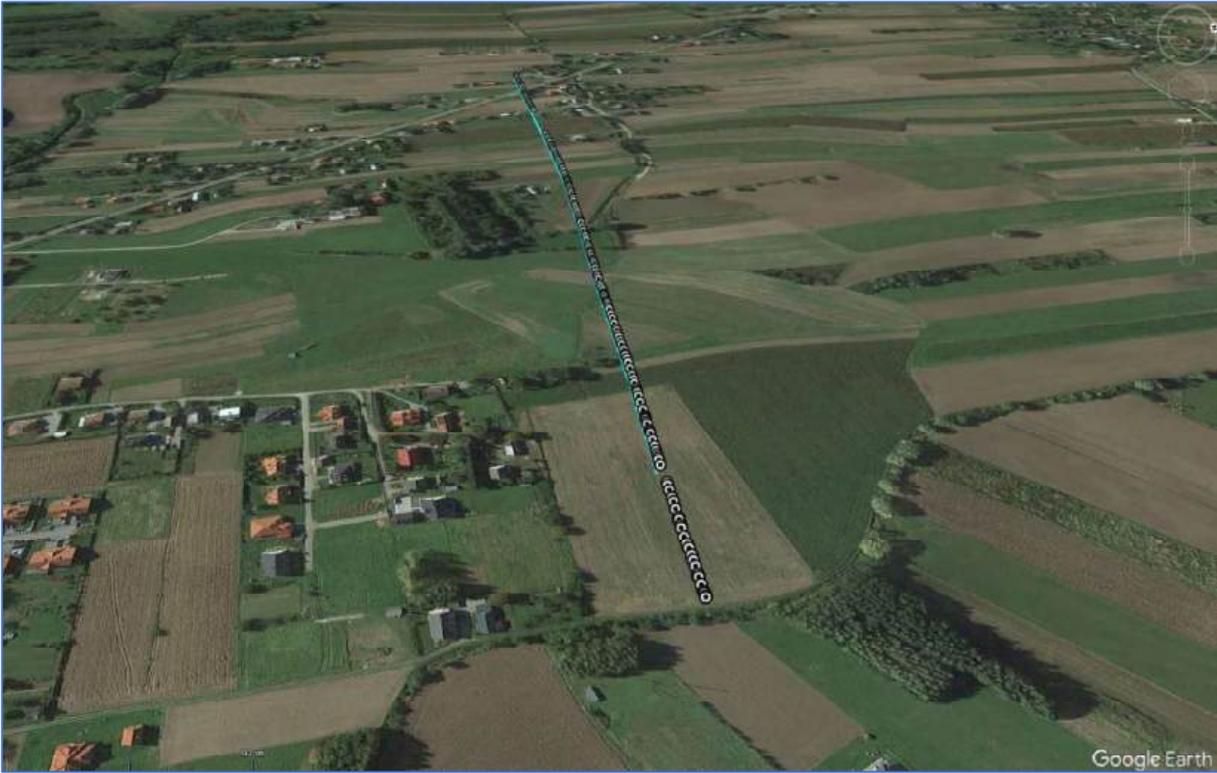
Figure 5-15: Characteristic points collected during measurements using the SCT method presented in Google Earth application [source GAZ-SYSTEM]

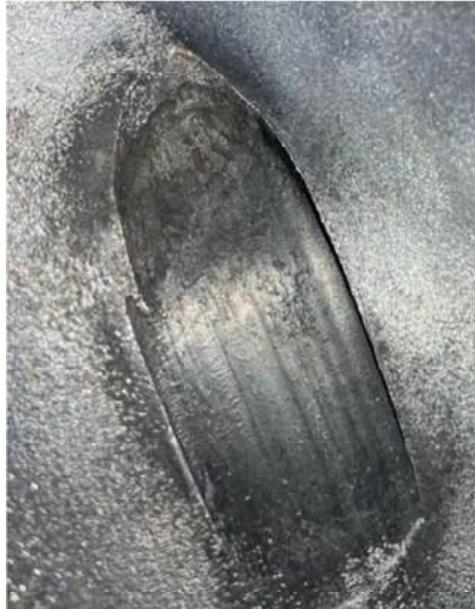
Figure 5-19: Metal loss anomaly of manufacturing origin classified as “Slivers”, detected based on the results of magnetic inspection pigging of the DN300 pipeline [39]

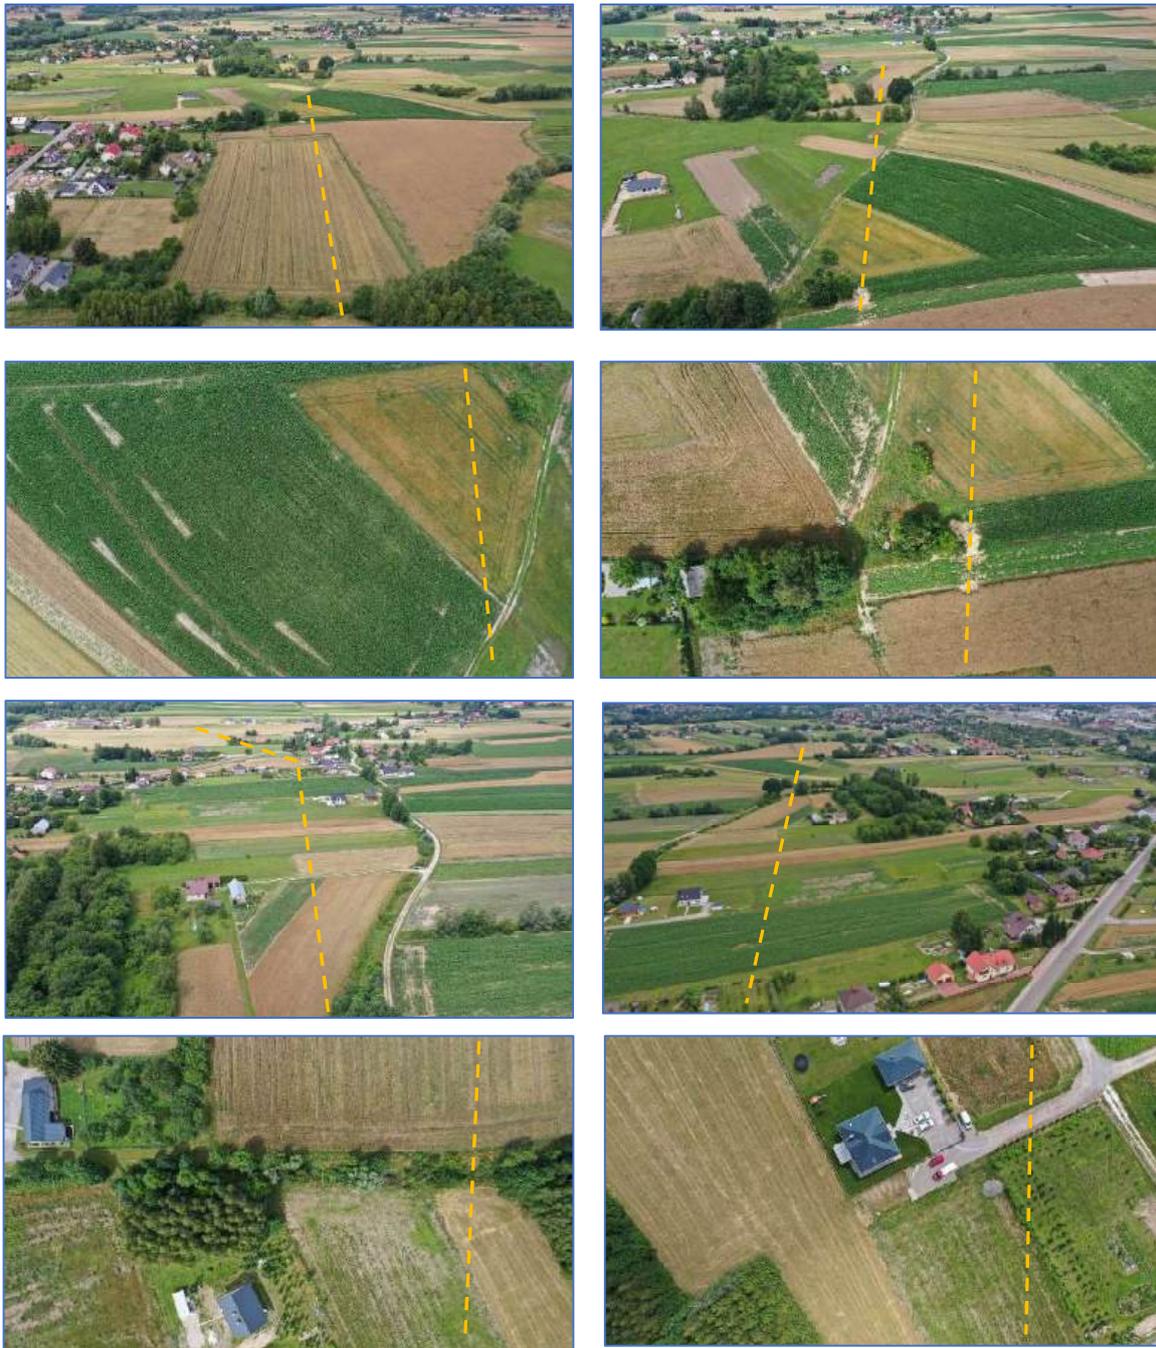
Figure 5-22: Photographs taken with a camera installed on a drone, taken from a 50 and 120 m suspension, with the approximate location of the gas pipeline in the field marked on the drawings with a dashed line [source GAZ-SYSTEM]
